PENRITH CITY COUNCIL

**CRANEBROOK OVERLAND FLOW
FLOOD STUDY**

OCTOBER 2022

DRAFT FOR PUBLIC EXHIBITION

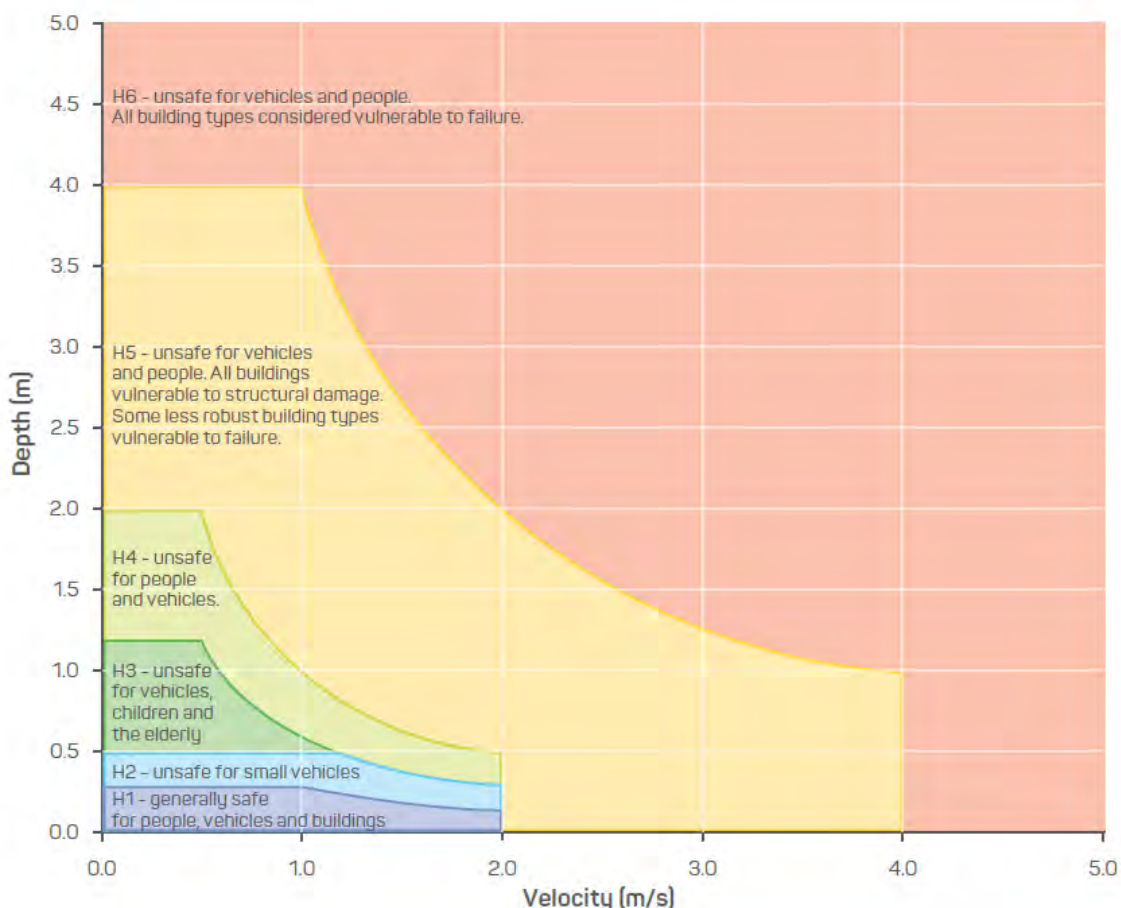
Flood hazard categories may be assigned to flood affected areas in accordance with the definitions set out in ARR, 2019. Flood prone areas may be classified into six hazard categories based on the depth of inundation and flow velocity that relate to the vulnerability of the community when interacting with floodwater as shown in the illustration below which has been taken from ARR, 2019.

Flood Hazard Vulnerability Classification diagrams for the 5, 1 and 0.5% AEP flood events, as well as the PMF event based on the procedures set out in ARR, 2019 are presented on **Figures 6.12, 6.13, 6.14** and **6.15**, respectively.

It was found that areas classified as H5 and H6 are generally limited to the inbank areas of Boundary Creek and incised channelled areas, local farm dams and the man-made lakes in the lower reaches of the study catchments in storm events up to 0.5% AEP in intensity.

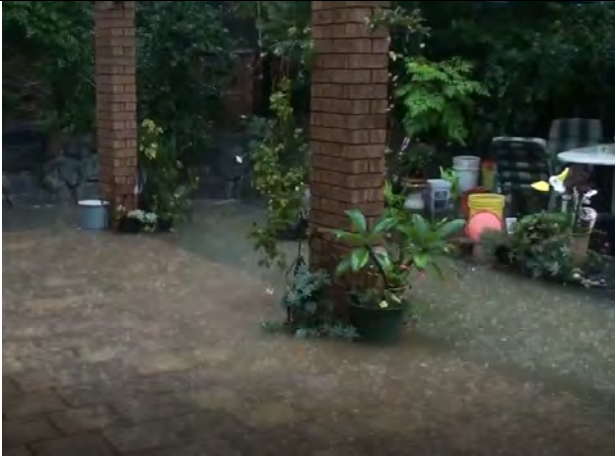
Plate C1.1 – (Photo taken at 19:00 hours) Floodwater ponding in rear of property that is located on Soling Crescent, Cranebrook.

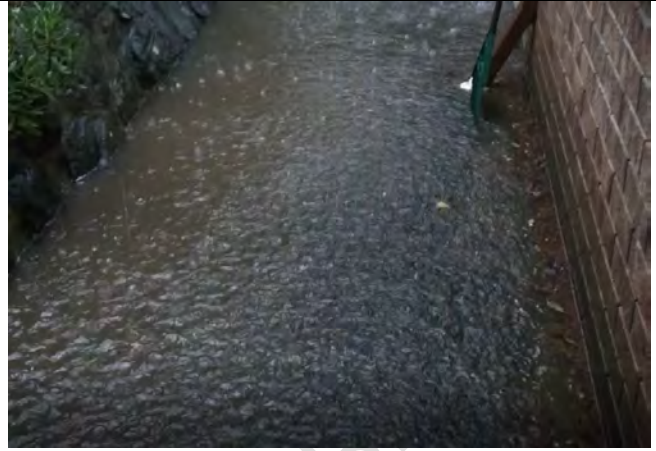
Plate C1.2 – (Photo taken at 19:00 hours) Floodwater ponding at side of property that is located on Soling Crescent, Cranebrook.

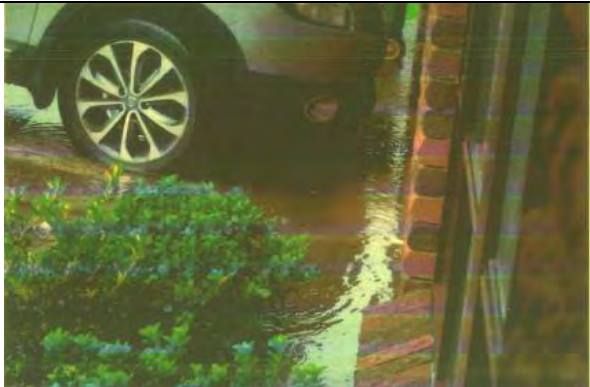
Plate C2.1 – Floodwater ponding at front of property that is located on Barry Coe Place, Cranebrook.

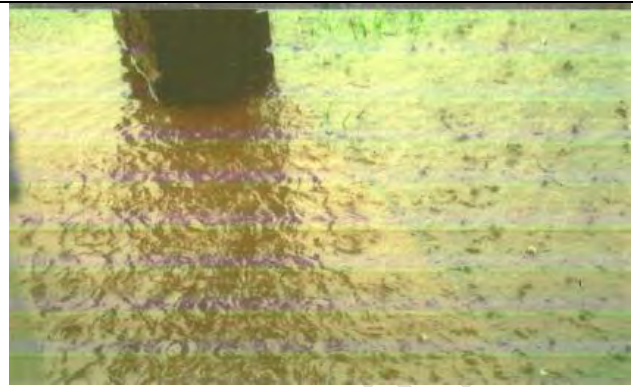
Plate C2.2 – Floodwater ponding at front of property that is located on Barry Coe Place, Cranebrook.

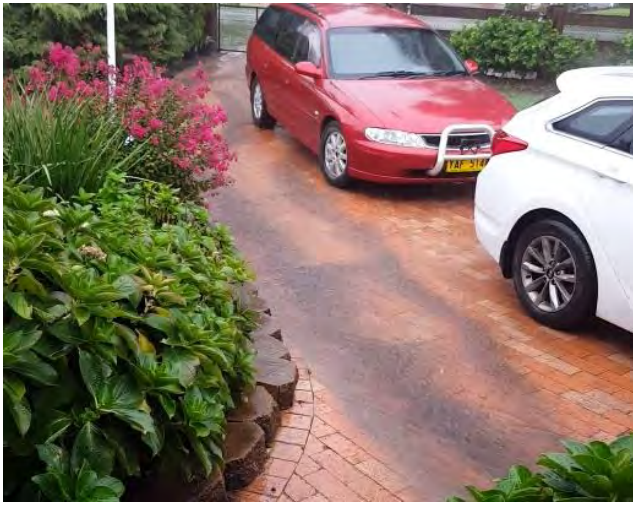
Plate C3.1 – (Photo taken at 17:30 hours) Overland flow along driveway of property that is located on Linden Crescent, Cranebrook.

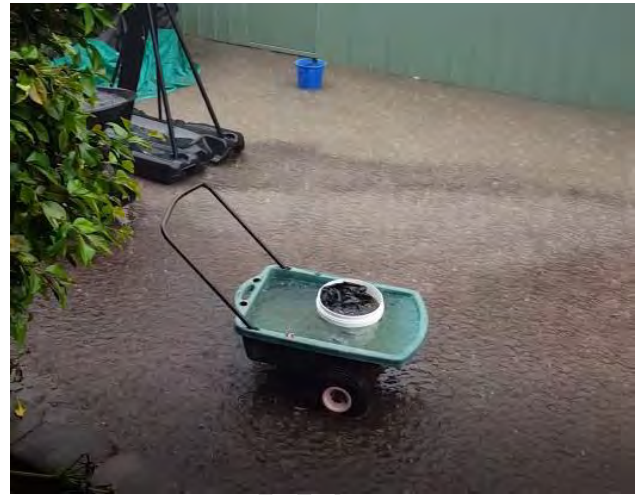
Plate C3.2 – (Photo taken at 17:30 hours) Floodwater ponding at rear of property that is located on Linden Crescent, Cranebrook.

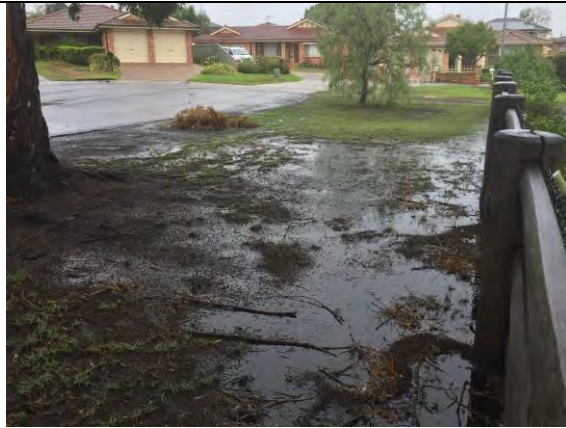
Plate C4.1 – Floodwater ponding between road and front of properties that are located on the western side of Linden Crescent, Cranebrook.

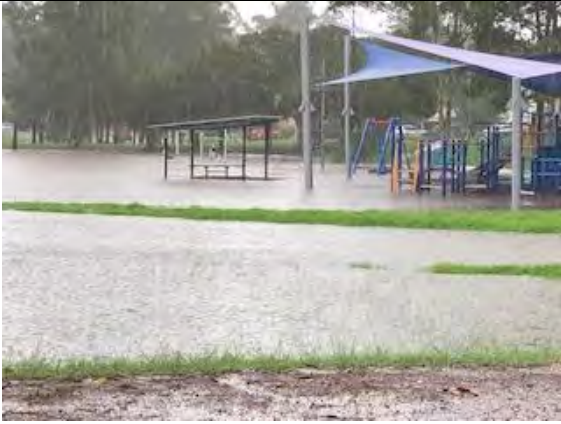
Plate C5.1 – (Photo taken at 12:00 hours) Floodwater ponding in the Borrowdale Way Basin No. 1.

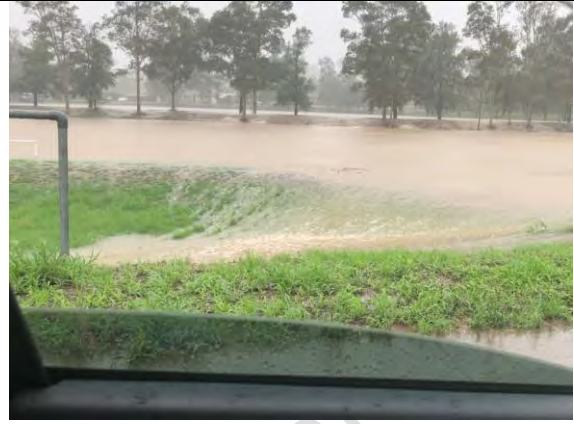
Plate C5.2 – (Photo taken at 15:00 hours) Floodwater surcharging the spillway of the Borrowdale Road Basin No. 2.

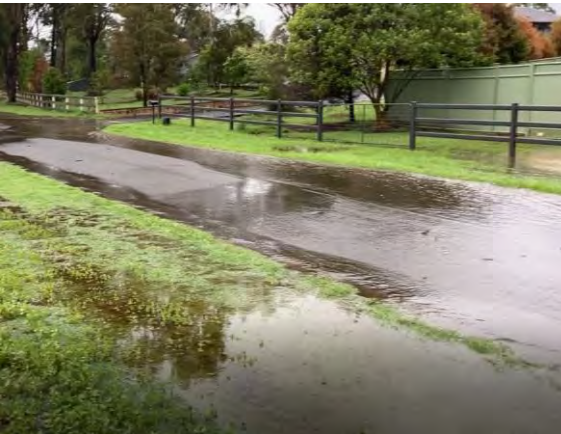
Plate C5.3 – Flooding on Woodside Glen, Cranebrook.

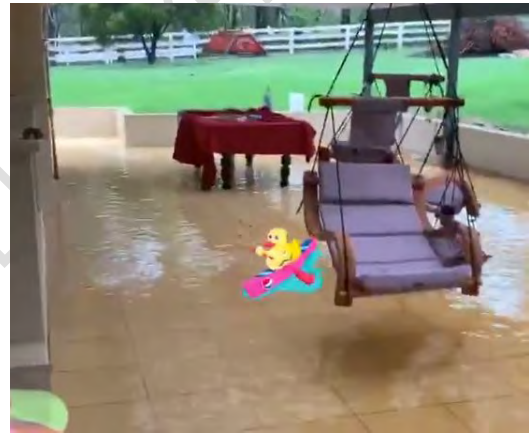
Plate C5.4 – (Photo taken at 11:40 hours) Flooding in rear of property that is located on Woodside Glen, Cranebrook.

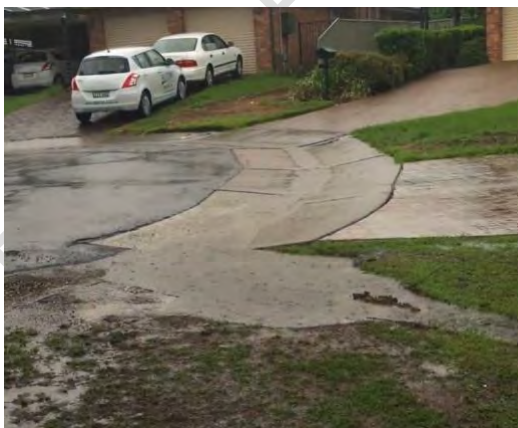
Plate C5.5 – (Photo taken at 10:00 hours) Concentrated flow discharging from gutter in Linden Crescent, Cranebrook.

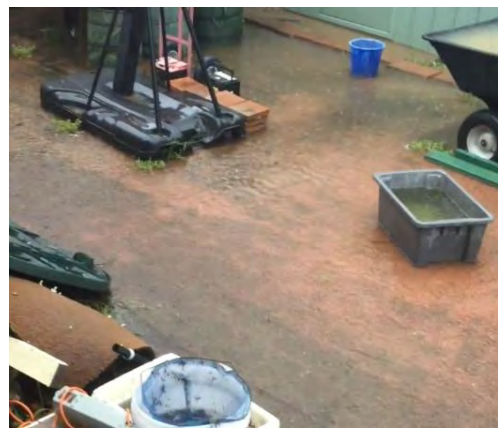
Plate C5.6 – (Photo taken at 13:30 hours) Floodwater ponding at rear of property that is located on Linden Crescent, Cranebrook.

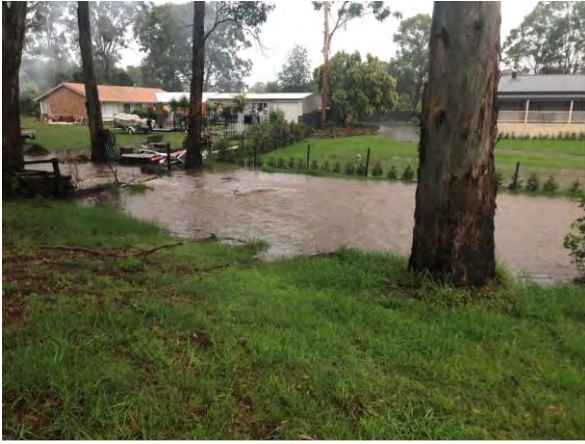
Plate C5.7 – Flooding on property that is located on Kenilworth Crescent, Cranebrook.

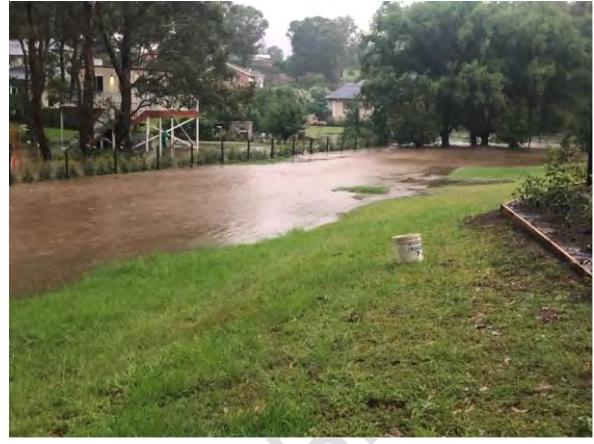
Plate C5.8 – Flooding on property that is located on Kenilworth Crescent, Cranebrook.

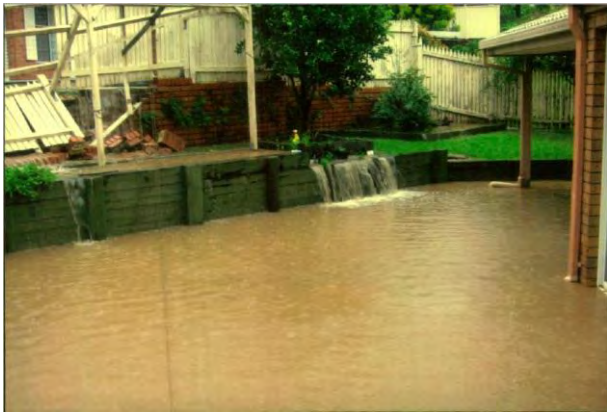
Plate C6.3 – Flooding at rear of property that is located on Waterfall Crescent, Cranebrook.
